## TEST REPORT

No. : SZIN1612017167PS

Sample Name : TIP-N-TELL TRB3 TILT DISPCAY LABEL  
Product Specification : 98MM\*71MM  
Manufacturer : INDEX PACKAGING  
Buyer : WUXI PRMIERSE  
Material and Mark : POLYSTYRENE

Test Item: Angle Test

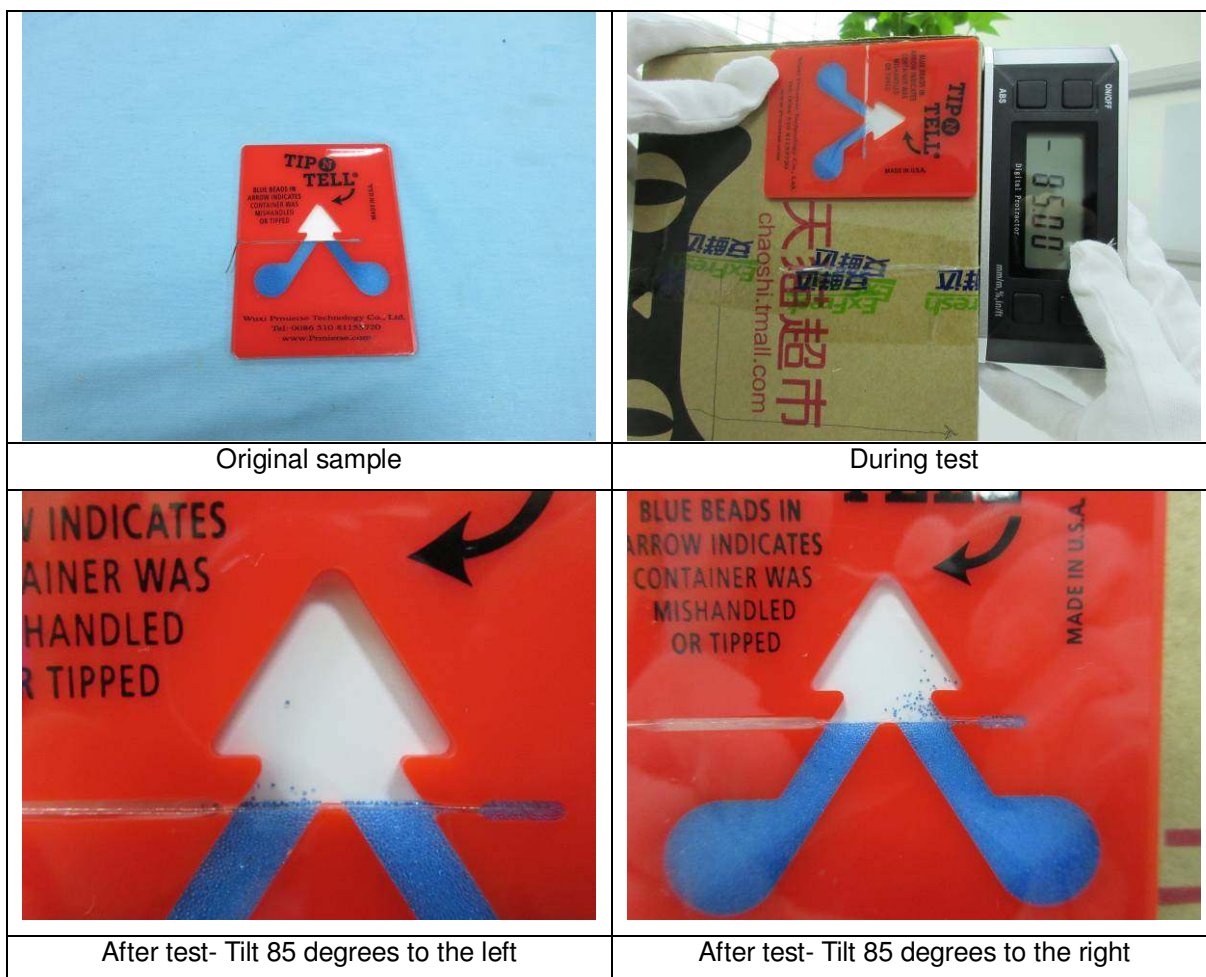
Test Photo:

Test Method: Provided by client, attach the sample to the packaging box, then tilt the box to the left or right and check whether the blue sand fall into the triangle area or not.

| Test Condition | Test Result | Client's Requirement | Conclusion |
|---|---|---|---|
| Tilt 85 degrees to the left | Some sand fall into the triangle area | Sand fall into the triangle area | Pass |
| Tilt 85 degrees to the right | Some sand fall into the triangle area | Sand fall into the triangle area | Pass |
| Tilt 89 degrees to the left | Some sand fall into the triangle area | Sand fall into the triangle area | Pass |
| Tilt 89 degrees to the right | Some sand fall into the triangle area | Sand fall into the triangle area | Pass |
